**SAS Superstructure**

Daily Diary Report by Bid Item

Diary #: 738 Const Calendar Day: 192 Date: 13-Dec-2012 Thursday

**04-0120F4
04-SF-80-13.2/13.9
Self-Anchored
Suspension Bridge****Weather****Temperature** 7 AM 40 - 50 12 PM 40 - 50 4PM 40 - 50**Precipitation** 0.00"**Condition** Partly overcast and coldWorking Day ☐ If no, explain:**Diary:**

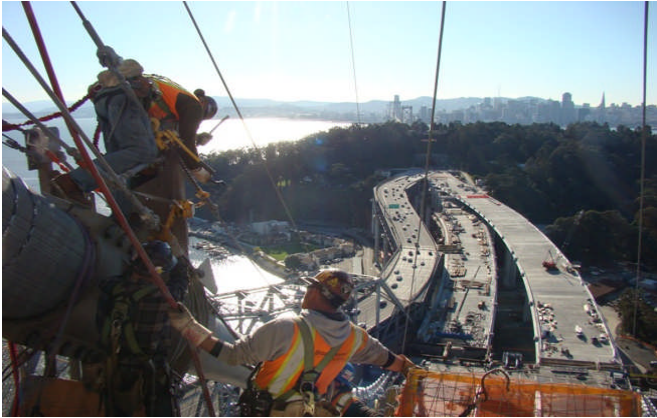
ABF ironworkers in the process of reinstalling the inboard handrope at panel point 40 South.

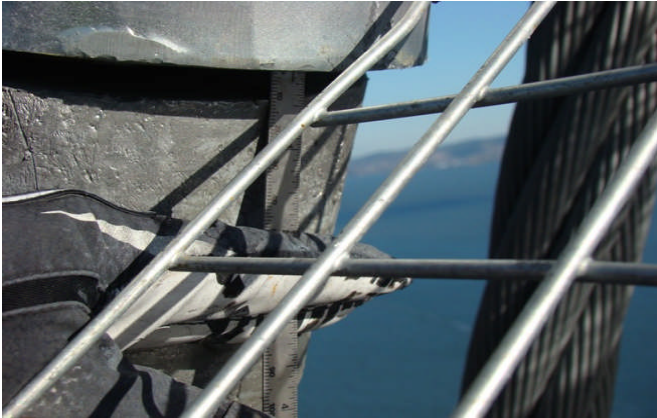
Gap between the suspender zinc button and clamp at PP30N on the downhill inboard side.

- Performed an inspection on the suspender rope clamps from panel points 10 to 48 on both the north and south cables. The main focus of this inspection was to identify and measure the gap between the suspender rope zinc button and the suspender clamp. Gaps between these two structural components were measured on the north sidespan only since the catwalk was not obstructing access to the edge. The table below is the gap measurements in millimeters taken on the north sidespan:

Panel Point	Outboard		Inboard	
	Uphill	Downhill	Uphill	Downhill
10	9	7	7	8
12	13	8	8	11
14	6	4	5	7
16	7	9	9	7
18	3	8	7	8
20	6	7	9	7
22	8	7	7	8
24	8	10	5	13
26	5	8	9	9
28	8	7	8	12
30	4	9	6	12
32	7	6	5	10
34	8	7	9	7

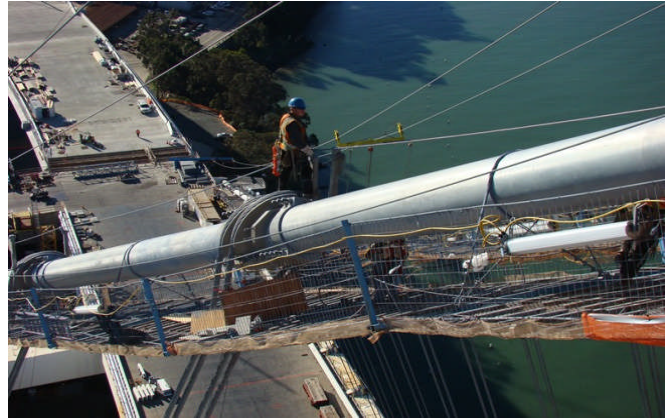
ABF ironworker in the process of reinstalling the inboard handrope at panel point 38 South.
